**WORK PLAN FOR
ASBESTOS ABATEMENT
OLD ADMINISTRATION BUILDING
123 JOHNS ROAD
BOERNE, TEXAS 78006**

**STC ENVIRONMENTAL SERVICES, INC.
STC PROJECT NO. 220403**

**DATE OF ISSUE
October 28, 2022**

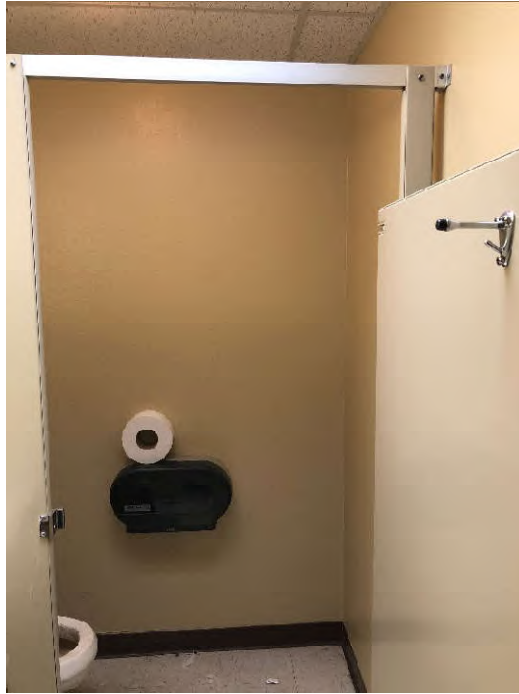
PHOTO 3: Shows the sheetrock wall system with wallpaper sampled in restrooms throughout the building (Samples SR-03-11 through SR-03-13). Testing of this material did not indicate the presence of asbestos.

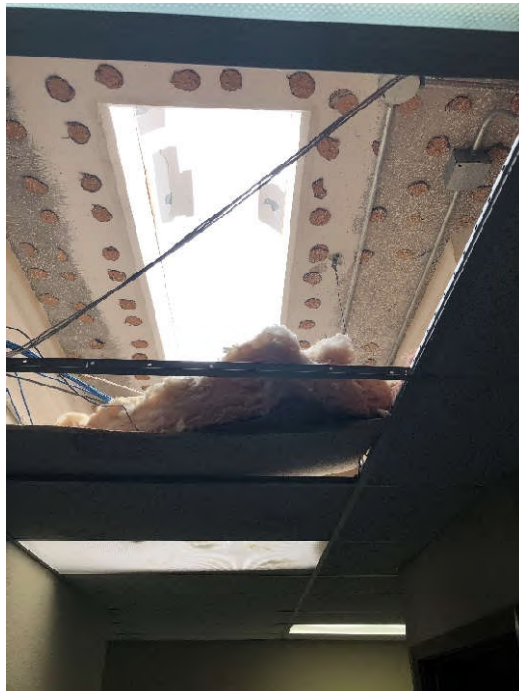
PHOTO 4: Shows the brown mastic sampled from the concrete ceiling deck in the common hallway (Samples CM-01-14 through CM-01-16). Testing of this material did not indicate the presence of asbestos.

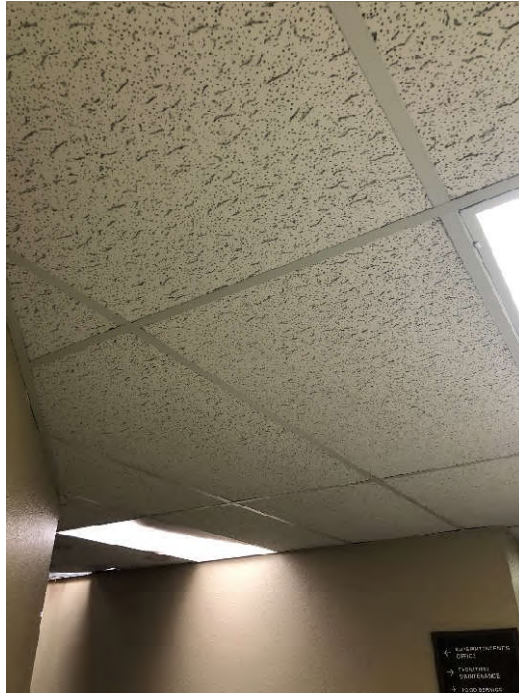
PHOTO 5: Shows the 2'x4', ceiling tile with pinhole and fissure pattern sampled throughout the building (Samples CT-01-17 through CT-01-19). Testing of this material did not indicate the presence of asbestos.

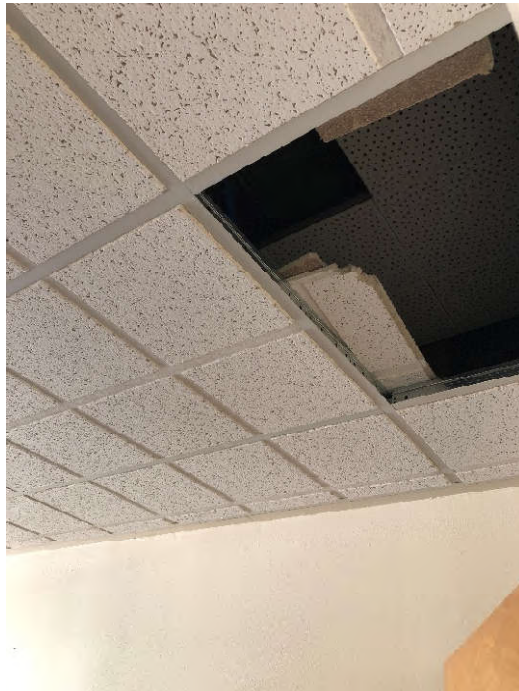
PHOTO 6: Shows the 2'x4', ceiling tile with 1'x1' inset pattern sampled in the office located across from the center storage room (Samples CT-02-20 through CT-02-22). Testing of this material did not indicate the presence of asbestos.

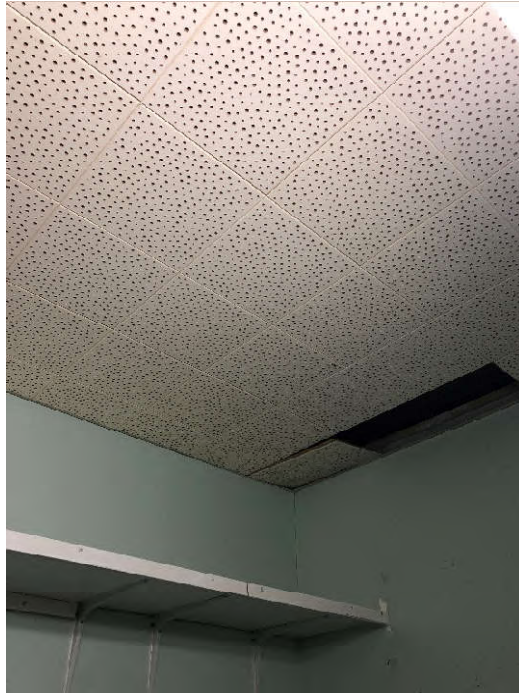
PHOTO 7: Shows the 1'x2', ceiling tile with pegboard pattern sampled in the center storage room (Samples CT-03-23 through CT-03-25). Testing of this material did not indicate the presence of asbestos.

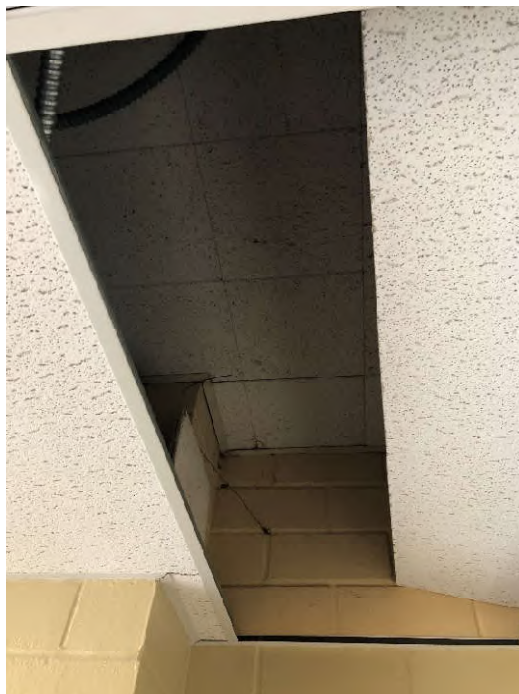
PHOTO 8: Shows the 1'x1', ceiling tile with crater pattern sampled above the ceiling grid located in the north foyer (Samples CT-04-26 through CT-04-28). Testing of this material did not indicate the presence of asbestos.

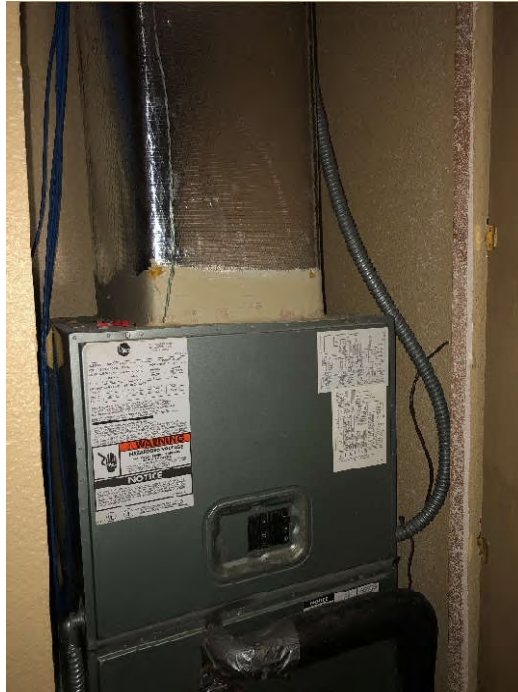
PHOTO 9: Shows the off-white mastic on HVAC duct sampled in the HVAC closet located in the IT Server Room (Samples HVAC-01-29 through HVAC-01-31). Testing of this material did not indicate the presence of asbestos.

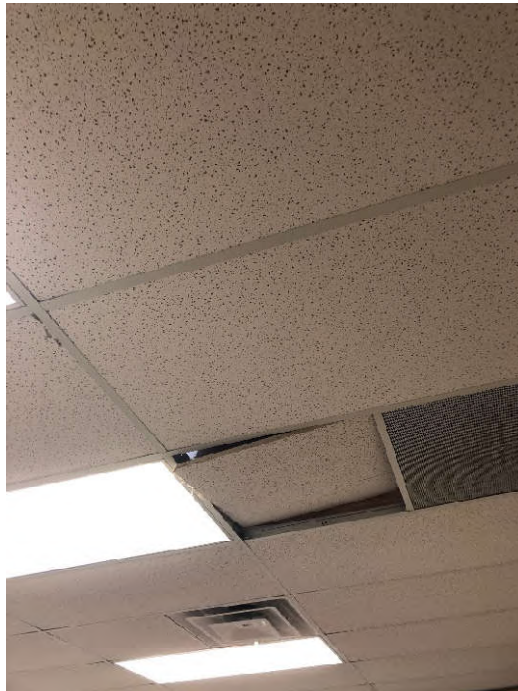
PHOTO 10: Shows the 2'x4', ceiling tile with pinhole and crater pattern sampled in the Business Office area (Samples CT-05-32 through CT-05-34). Testing of this material did not indicate the presence of asbestos.

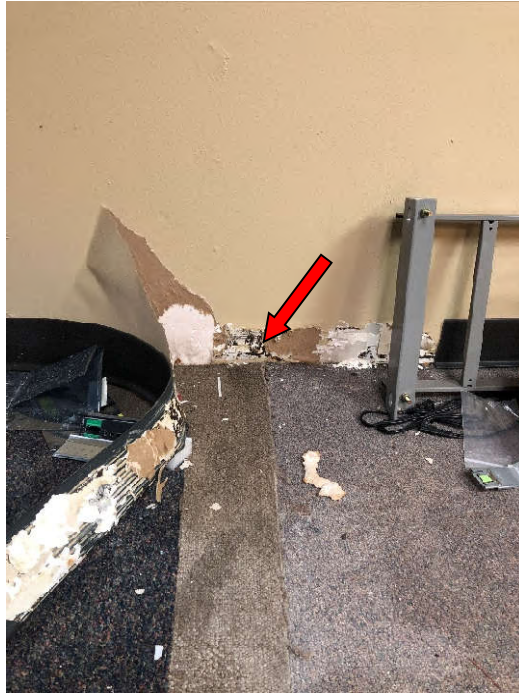
PHOTO 11: Shows the brown baseboard mastic sampled in the IT Server Room (Samples WM-01-35 through WM-01-37). Testing of this material did not indicate the presence of asbestos.

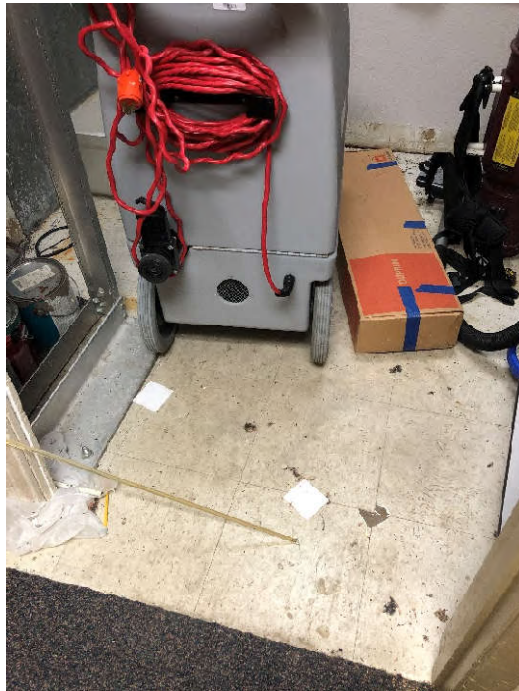
PHOTO 12: Shows the off-white, 12”x12”, vinyl floor tile with gray splotches and yellow mastic sampled in the Custodial Closet (Samples VCT-01-38 through VCT-01-40). Testing of this material did not indicate the presence of asbestos.

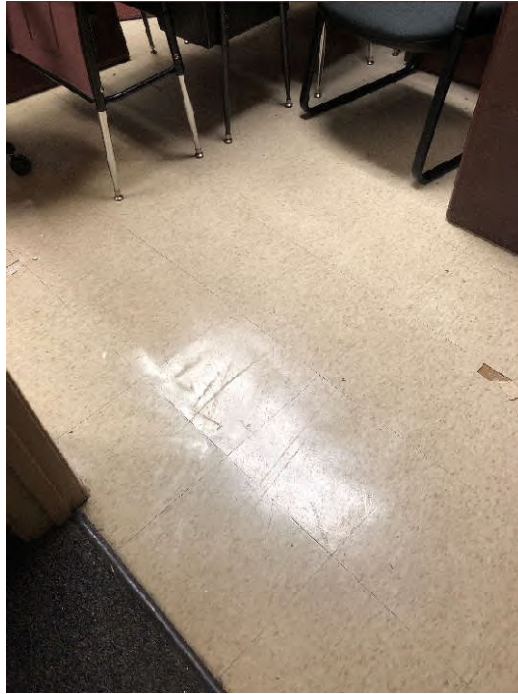
PHOTO 13: Shows the beige, 12”x12”, vinyl floor tile with tan splotches and yellow mastic sampled in the Dining Room (Samples VCT-02-41 through VCT-02-43). Testing of this material did not indicate the presence of asbestos.

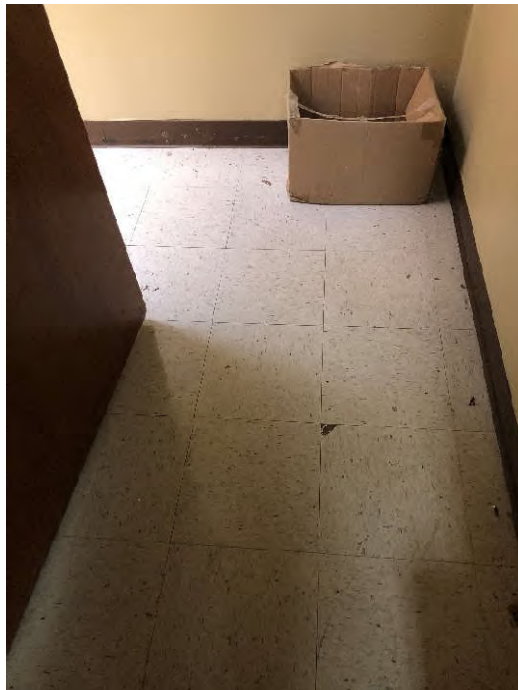
PHOTO 14: Shows the white, 12”x12”, vinyl floor tile with blue and gray splotches and yellow mastic sampled in the Board Room Restroom (Samples VCT-03-44 through VCT-03-46). Testing of this material did not indicate the presence of asbestos.

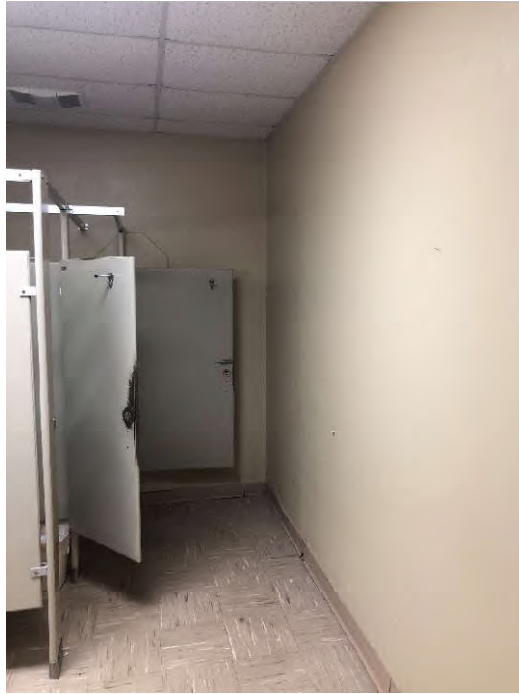
PHOTO 15: Shows the tan, 12"x12", vinyl floor tile with beige and brown streaks and yellow mastic sampled in the main men's and women's restrooms (Samples VCT-04-47 through VCT-04-49). Testing of this material did not indicate the presence of asbestos.

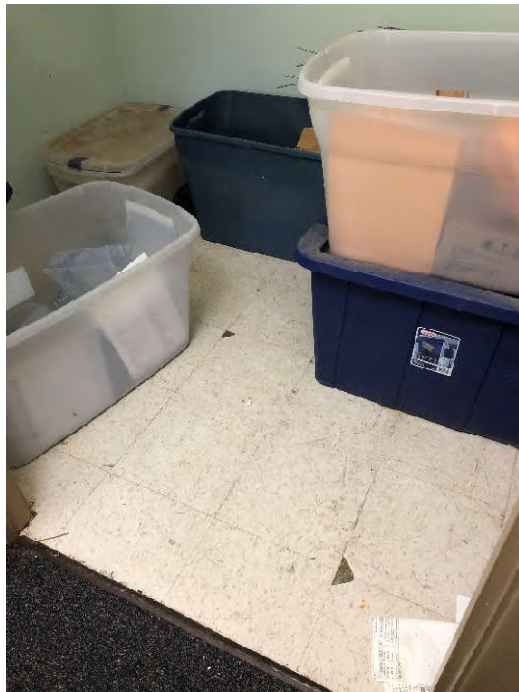
PHOTO 16: Shows the off-white, 12"x12", vinyl floor tile with gray splotches and yellow mastic sampled in the center storage room and HVAC closet (Samples VCT-05-50 through VCT-05-52). Testing of this material did not indicate the presence of asbestos.

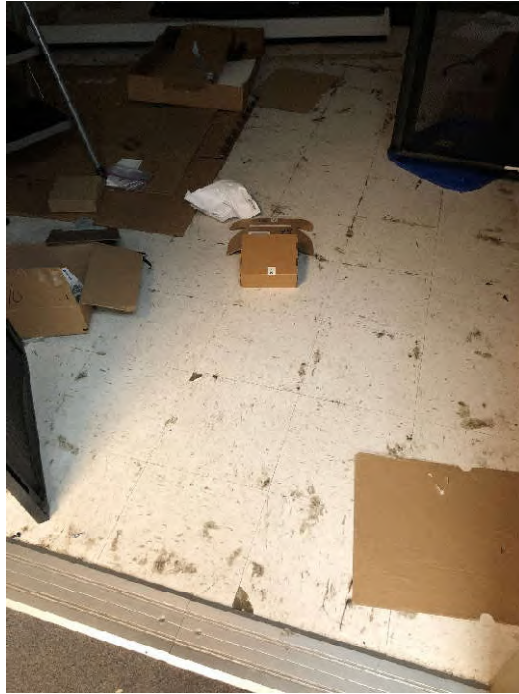
PHOTO 17: Shows the white, 12"x12", vinyl floor tile with beige splotches and yellow mastic sampled in the IT Server Room (Samples VCT-06-53 through VCT-06-55). Testing of this material did not indicate the presence of asbestos.

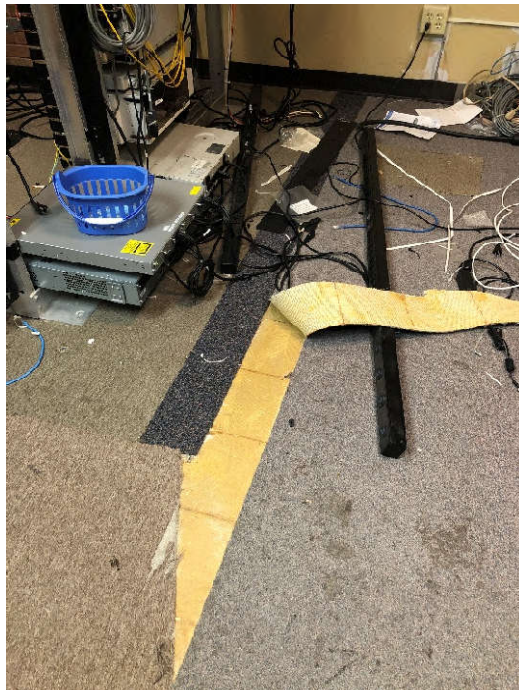
PHOTO 18: Shows the beige, 9"x9", vinyl floor tile with black mastic sampled in the IT Server Room (Samples VCT-07-56 through VCT-07-58). The black mastic and vinyl floor tile indicated the presence of asbestos at a concentration of two (2) percent.

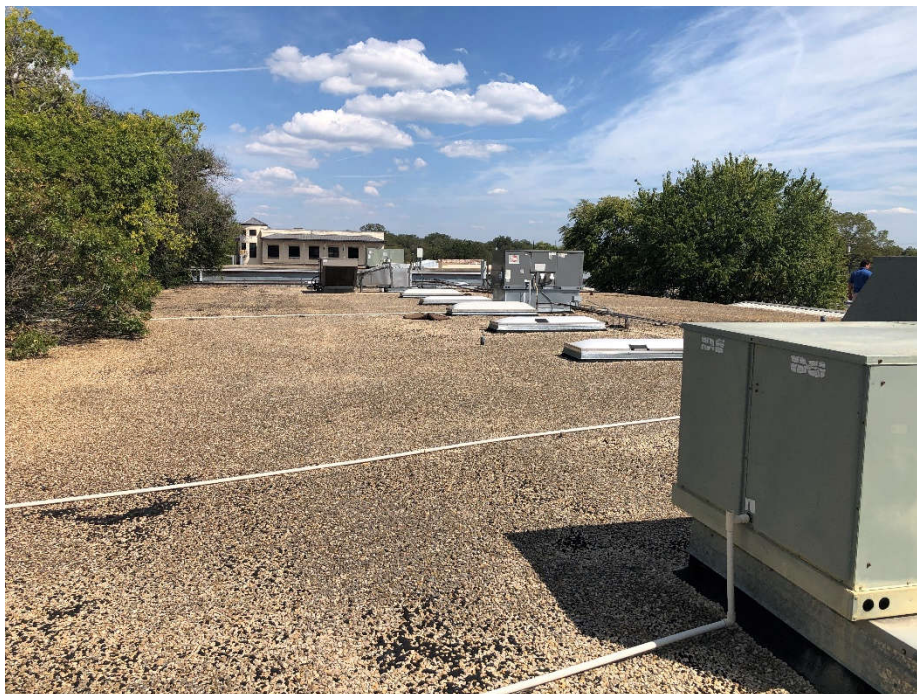
PHOTO 20: Shows the flat, gravel and tar roof of the building (Samples RC-01-62 through RC-01-64). Testing of this material did not indicate the presence of asbestos.

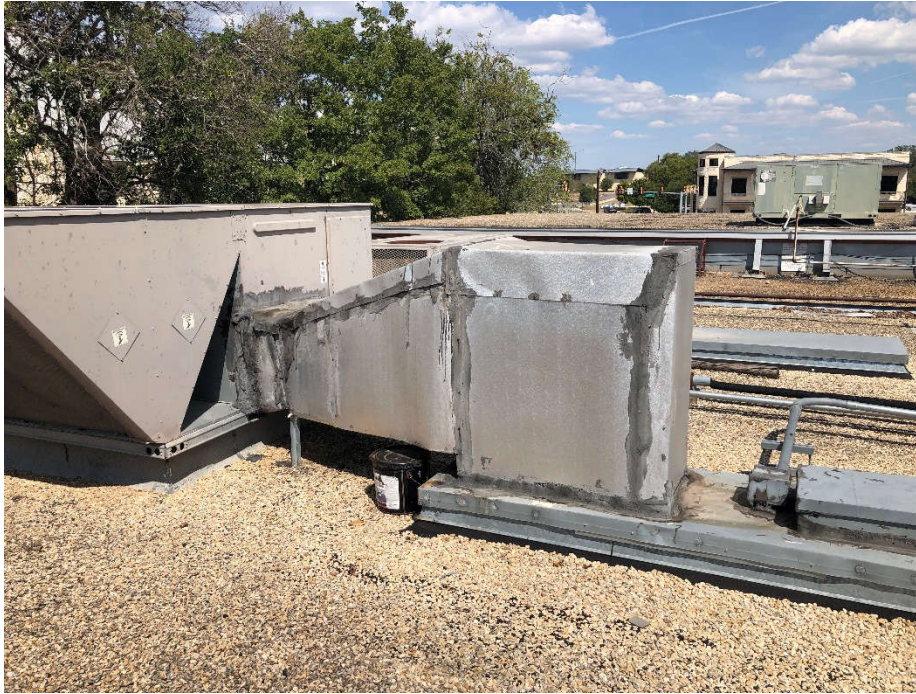
PHOTO 21: Shows the black/gray mastic sampled from metal HVAC duct located on the roof of the building (Samples HVAC-02-65 through HVAC-02-67). Testing of this material did not indicate the presence of asbestos.

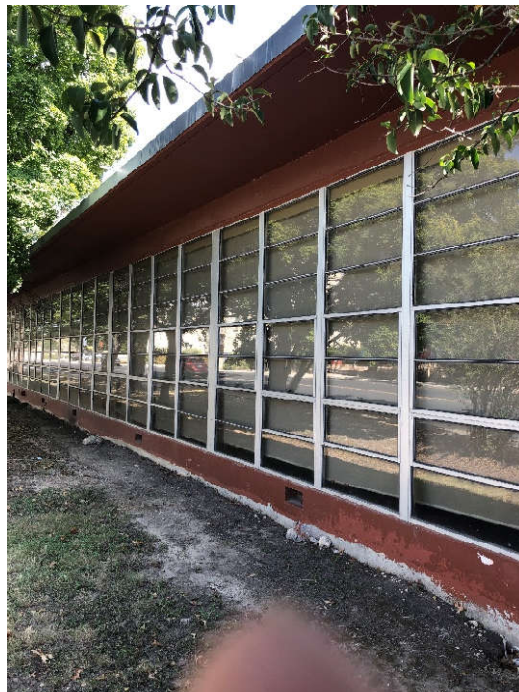
PHOTO 22: Shows the windows located on the north side of the building where residual window glazing was sampled (Samples WG-01-68 through WG-01-70). The residual window glazing indicated the presence of asbestos at a concentration of two (2) percent.

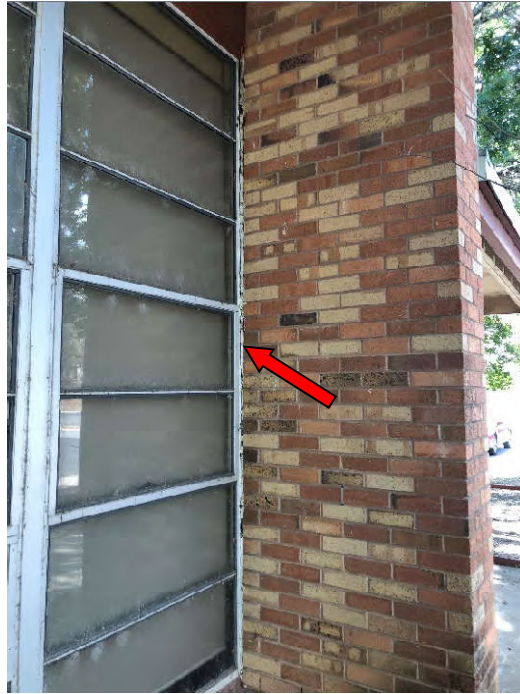
PHOTO 23: The red arrow indicates the window caulking sampled in between the metal window frame and the brick veneer (Samples WC-01-71 through WC-01-73). The caulking indicated the presence of asbestos at a concentration of two (2) percent.
